## MAINTENANCE REPORT - March 2021

### Calcot:

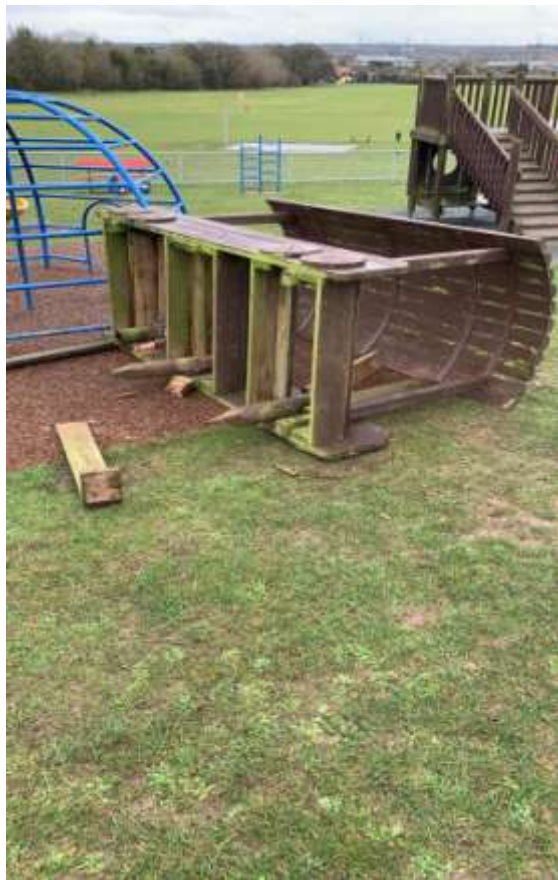
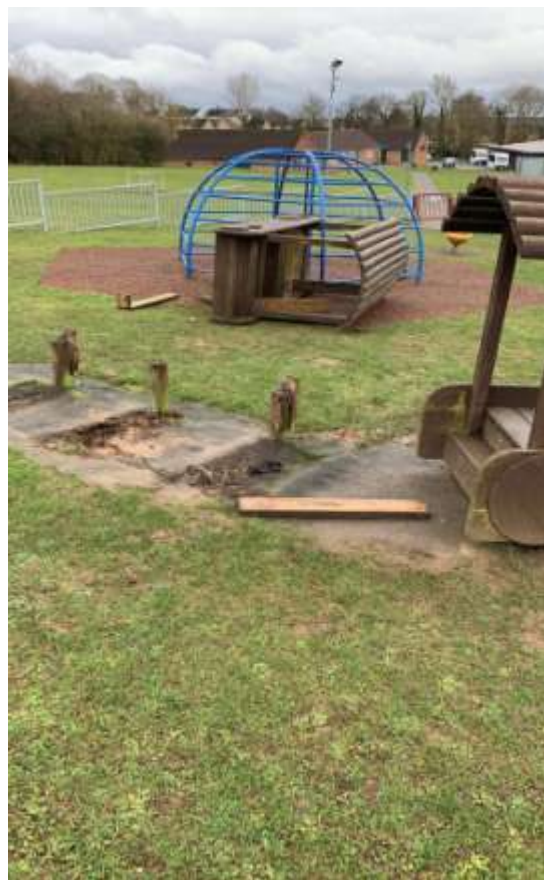
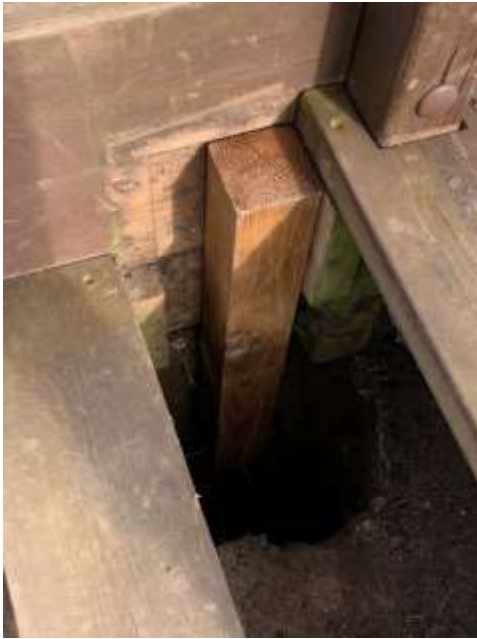
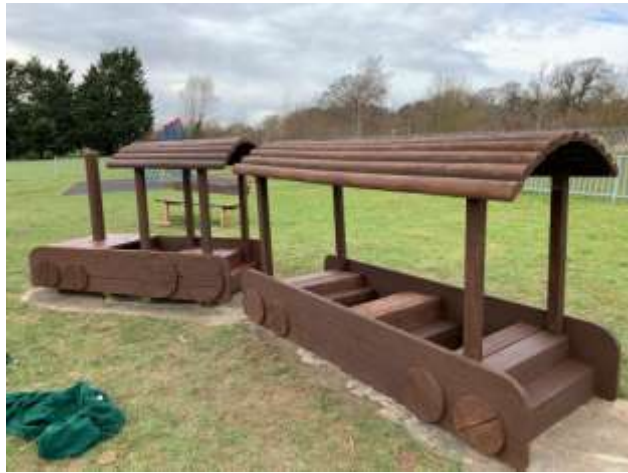
#### **Wooden Train in play area -**

West Berkshire Council forwarded to the Clerk details of two residents reporting vandalism at the Calcot recreation ground play area. Upon checking, it was discovered that the large wooden train had been pushed over onto its side, in the process breaking and splintering the retaining posts.

The parish maintenance officer, with some help, managed to get the train upright with considerable effort as it is very heavy.

The intention was to move it to the hall, make the area safe, then repair it. However, because of the weight they were unable to move it any distance, so had to leave it in the play area and wrap safety tape around it until it could be repaired.

Mark purchased new wood and bolts in order to carry out repairs.

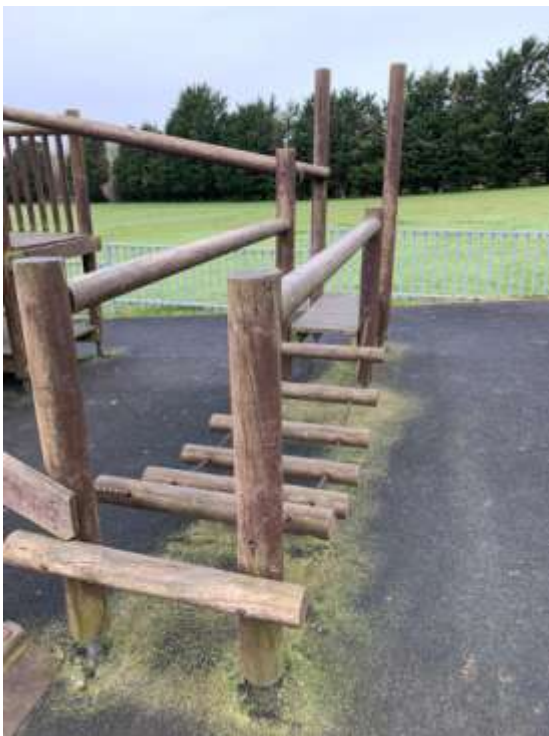
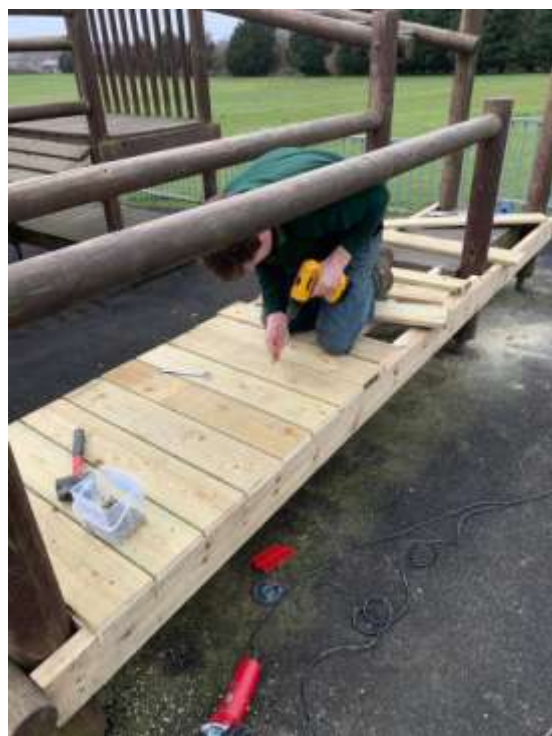
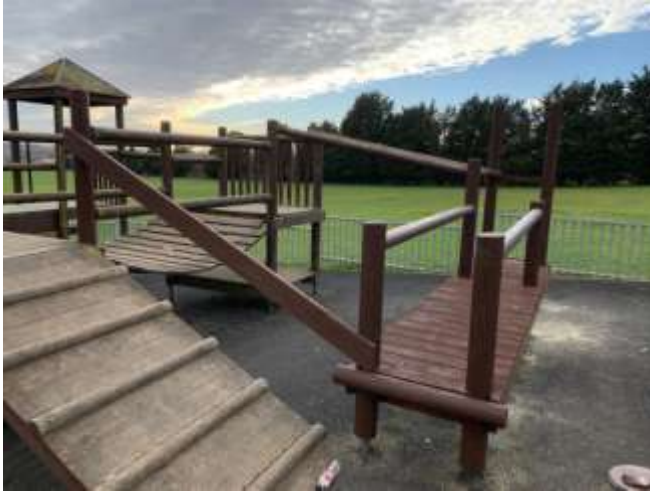
**Large wooden climbing frame in play area:**

During the last inspection by ROSPA, it was identified that the suspension bridge was high risk due to potential entrapment of feet/fingers. They also ascertained that some of the wood was rotted and chains worn. The bridge was replaced by a solid walkway.

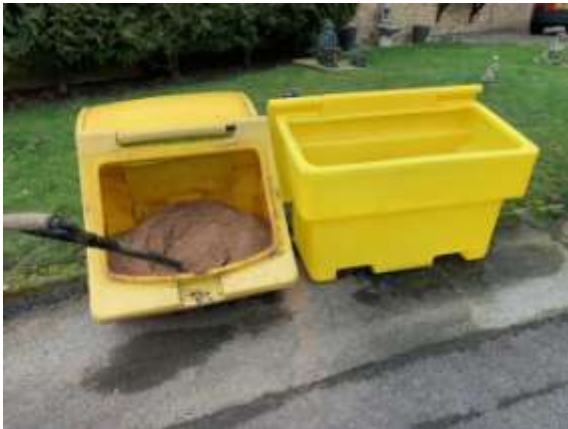
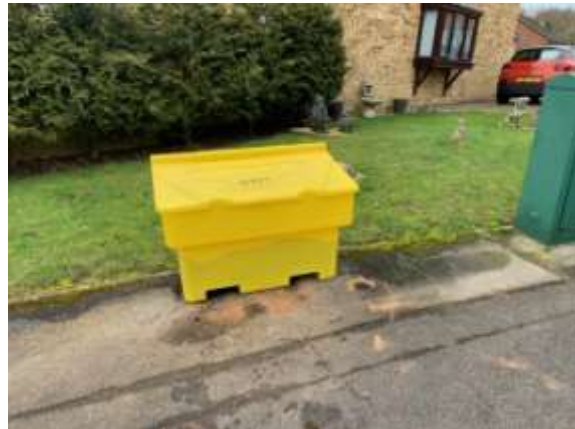
### **New Salt Bin:**

A request was received for a new salt bin at The Knoll as the existing one wasn't large enough. Mark replaced the existing bin with one that is twice the size. The new bin was in our store, therefore no cost was involved, and West Berkshire Council confirmed that their existing licence would cover the new bin as it would be in the same position.

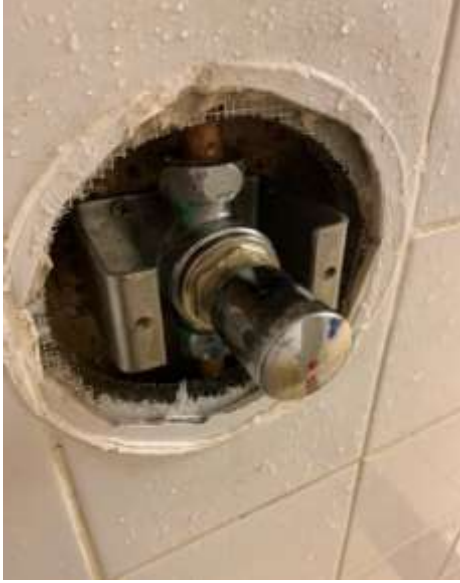
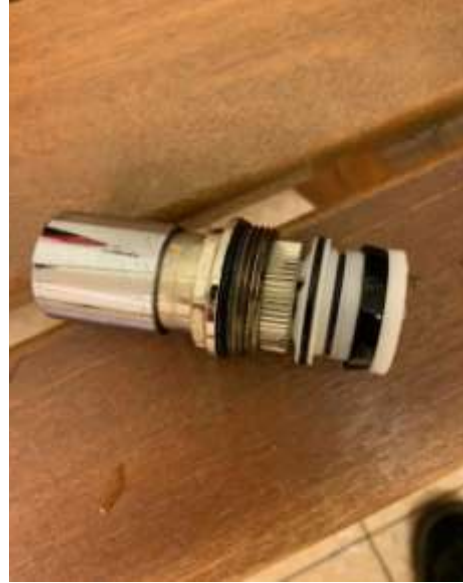
### **Turnhams Farm Changing Rooms:**

The football team that uses the changing rooms at Turnhams Farm recreation ground reported that the showers would not turn off after being used. The parish maintenance officer checked and ascertained that the push buttons were not 'popping out' in order to stop the flow of water.

Mark took apart the mechanisms for each shower, descaled and greased them, and put them back together.
